Total losses of fishing vessels due to the insufficient stability

P. Krata

Gdynia Maritime University, Gdynia, Poland

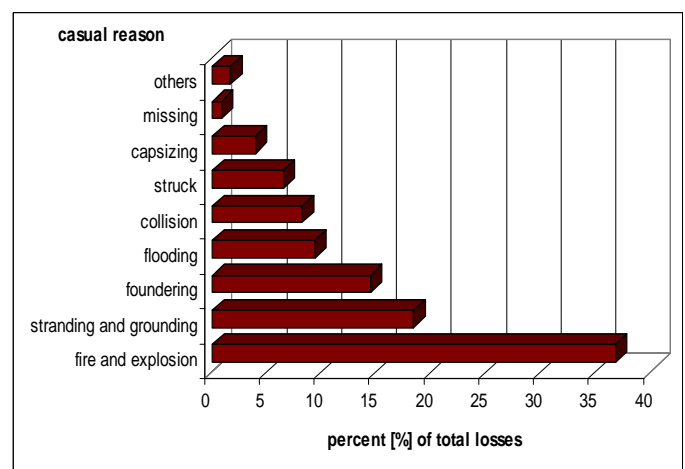
The distribution of the reason of analyzed fishing vessels' total losses is shown graphical in figure 1. The loss of stability involving capsizing of the ship is one of the rarely noticed reason of the total losses.

Its rate is only 4% of all casual causes. Although the rate of capsized vessels is much higher in the group of smaller ships, not considered in presented statistics.

Fig. 1. Distribution of the reason of fishing vessel total losses (source - own study based on data published in (Achutegui, Mendiola & Azofra 2000))

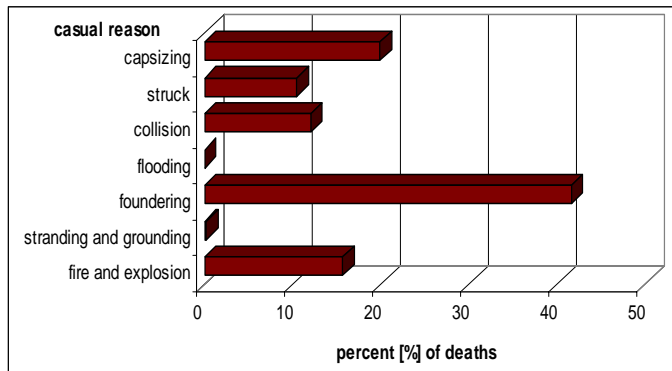
important reason of deaths on board of fishing vessels. The distribution of causes for loss of human life during fishing vessels' total losses is shown in figure 2.

Fig. 2. Distribution of the causes for deaths during fishing vessel total losses (source - own study based on data published in (Achutegui, Mendiola & Azofra 2000))

Capsizing is the second often reason of the loss of human life, although it causes only 4% of all total losses of fishing vessels. The rate of deaths during capsizing reaches almost 20%. The rate of death per one ship's loss is even worse. It is 7,07 loss of human being per one fishing vessel lost, when the average rate is 1,40 only. The distribution of the causes for deaths per one fishing vessel total loss is shown in figure 3.

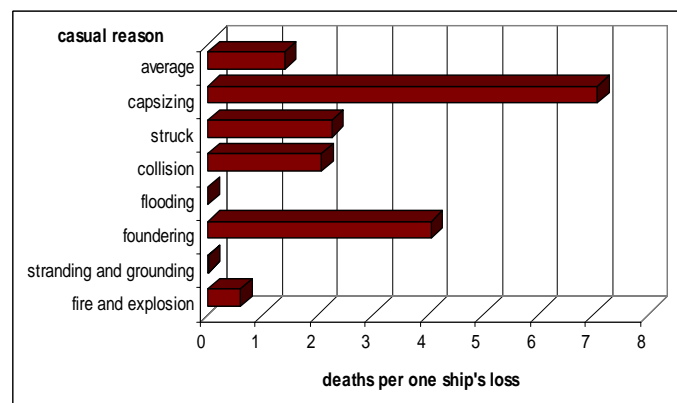
Fig. 3. Distribution of the causes for deaths per one fishing vessel total loss (source - own study based on data published in (Achutegui, Mendiola & Azofra 2000))

The comparison of the average rate of deaths and the characteristic high rate noticed for capsizing, shows the level of threat during the capsizing and generally the condition of insufficient stability. The rate of deaths per one capsizing disaster, which is over five time higher than average one, justify further consideration of this relative rare phenomenon.

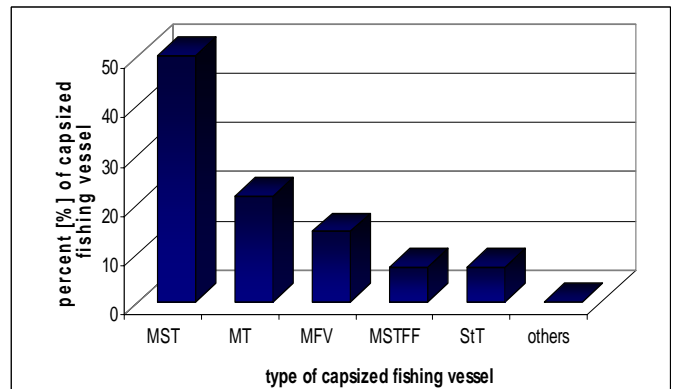
The distribution of capsizing rate by the type of the vessels is shown in figure 4. The symbols used in the graph are following: MST - motor stern trawlers, MT - motor trawlers, MFV - motor fishing vessels, MSTFF - motor stern trawlers fish factory, StT - steam trawlers. The names of vessels types correspond with the division used for statistic data collecting (Achutegui, Mendiola & Azofra 2000).

The predominating group of capsized fishing vessels represents motor stern trawlers and the second one motor trawlers. Those both types of ships suffered over 71% of all capsizing. It is characteristic for both of them, that the freeboard is relatively small. Additionally the stern trawlers have low and almost open stern, what is necessary for the type of fishing operations. The coexistence of such shape of the trawlers hull and the high rate of capsizing should be underlined.

Fig. 4. Distribution of capsizing rate by the type of lost vessel (source - own study based on data published in (Achutegui, Mendiola & Azofra 2000))

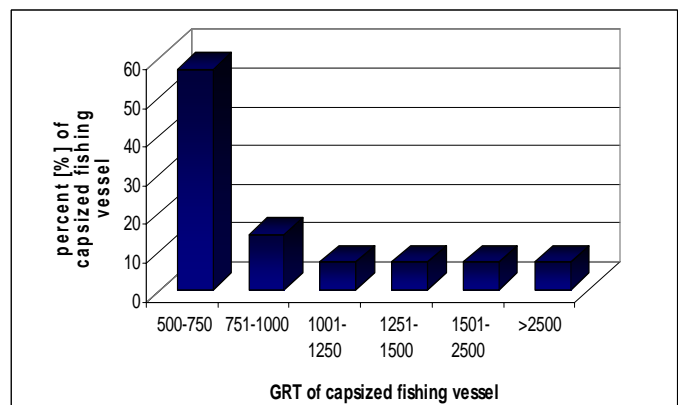
Fig. 5. Distribution of capsizing rate by GRT of lost vessel (source - own study based on data published in (Achutegui, Mendiola & Azofra 2000))

The next step was taking into consideration the size of the capsized fishing vessels. Six sizes up to the gross register tonnage were established. The distribution of capsizing rate by the GRT of fishing vessels is shown in figure 5. There is the strong relationship between the size of considered vessels and the rate of its capsizing. Over 57 % of capsized ships were under 750 GRT. The vessels of size smaller than 500 GRT were not taken into consideration.

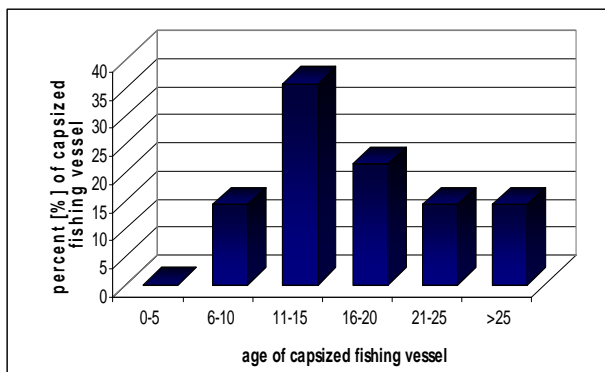
The last factor taken into consideration was the age of the capsized fishing vessels. Six age categories were established: ships from 0 to 5 years old - "new", 6 to 10 years old - "relatively new", from 11 to 15 years old - "middle age", 16 to 20 years old - "relatively old", 21 - 25 years old were considered as "old" and over 25 years old - "very old". The distribution of capsizing rate by the age of fishing vessel is shown in figure 6.

Fig. 6. Distribution of capsizing rate by the age of lost vessel (source - own study based on data published in (Achutegui, Mendiola & Azofra 2000))

The highest rate of capsizing was noticed for middle age ships (almost 36% of all capsized fishing vessels). The second most inflicted to capsizing group of vessels are relatively old ones. The figure 6. shows, that there is no rule - the older the worse.

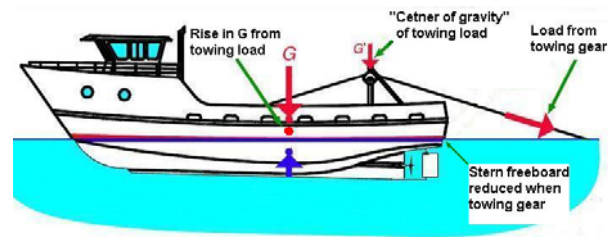
The criteria adopted by IMO represent the simple static attitude towards complicated nonlinear dynamic behavior of the vessel. The weather criterion, which is the attempt of dynamic stability calculation, is based on the static righting arm as well. The vessels shall be able to withstand the effect of severe wind and rolling in associated sea conditions in which the vessel will operate (IMO 1993). But no dynamic evaluation of the rolling and wind gusts take place in course of stability calculation. Additionally, when the stability of fishing vessel is to be evaluated, some important circumstances are omitted. First of all the influence of fishing gear's towing should be taken into consideration. The arrangement of additional forces affecting the trawler is shown in figure 7.

Fig. 7. The towing load affecting ship's stability (source (Womack 2002))

Another effect resulting the danger to fishing vessels may be the water trapped on deck and its dynamic influence (Jankowski & Laskowski 2006). Such situation is most likely during the towing of fishing gear by the small trawler. There is an accumulation of free board lowering (see figure 7) and the characteristic construction of stern trawlers having almost open stern for fishing operations. The water trapped on the deck may also come into the processing spaces, what considerably effects the ships stability and results deeper rolling on the seas. The example of such situation may be the capsizing of fishing vessel *Arctic Rose*. The disaster was described in details (Lieutenant 2002).

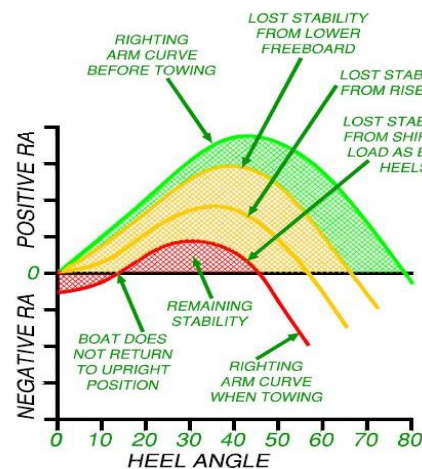
The stability of the vessel towing the fishing gear is reduced by some effects. The first is the rise of the center of gravity, due to fishing gear load placed virtually on the top of cable reels. The other reason for the stability decay is the lower freeboard, especially in the stern of the trawler. That may be the reason of the loss of relatively small ships, which capsize the most often (see statistic in figure 5). The next factor affecting ships' stability is the shift of load as the vessel heel. The negative effects of towing the fishing gear are shown in figure 8.

Fig. 8. Negative effects of towing of fishing gear (source (Womack 2002))

The next circumstance exposing fishing vessels to the risk of capsizing is omitting in stability calculations the load of fishing gear being towed by the trawlers. The towing load results in lowering of freeboard and rising in the height of center of gravity.

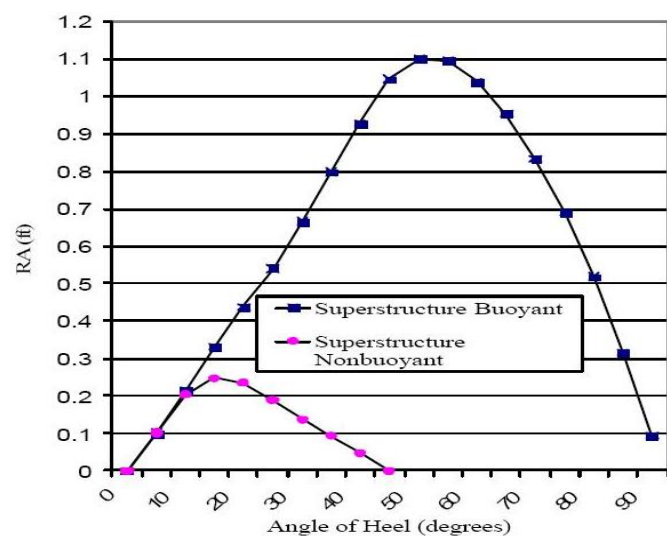
The fishing vessel *Arctic Rose* had been disappeared in the Bering Sea on April 2, 2001, killing all fifteen men onboard. The U. S. Coast Guard convened a Formal Marine Board of Investigation to determine what had happened to the vessel and why it had happened. According to the analysis, the most likely reason the *Arctic Rose* sank had been progressive flooding from the aft weather deck to the processing space and the flooding then progressed to the galley, fish hold, and engine room through non-watertight doors and hatches (Lieutenant 2002). The effect of loss of buoyancy of the superstructure on the static righting arm curve is shown in figure 9. With the superstructure nonbuoyant, the angle of maximum righting arm is at the angle of deck edge immersion. With the superstructure buoyant, the angle of maximum righting arm is increased to the angle at which the top of the superstructure is immersed. However, if the superstructure cannot physically be kept watertight due to openings without closures and operational considerations, the buoyancy is lost (Lieutenant 2002).

Fig. 9. Arctic Rose righting arm curve RA: openings closed - upper curve and openings remaining open - lower curve (source (Lieutenant 2002))

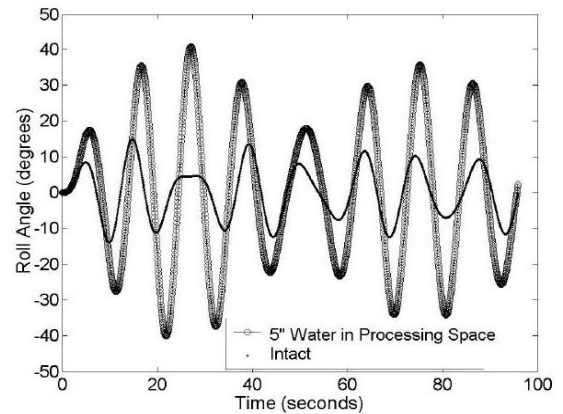
Additionally, water on deck often leads to progressive flooding into spaces inside the fishing vessel in which watertight doors and hatches have been left open, which is precisely the most likely scenario of the loss of the *Arctic Rose* (Lieutenant 2002). The sophisticated analysis of dynamic behavior of *Arctic Rose* containing the water inside its hull was performed. The results of the analysis are shown in figure 10. The great increase in rolling amplitude is evident.

Fig. 10. Roll angle time history for Arctic Rose (source (Lieutenant 2002))
